December 14, 2020

Nutrient Holdings, LLC
520 River View Drive, #506
New Castle, CO 81647

SGM
118 West Sixth Street, Suite 200
Glenwood Springs, CO 81601
970-384-9017

Nutrient Farm PUD

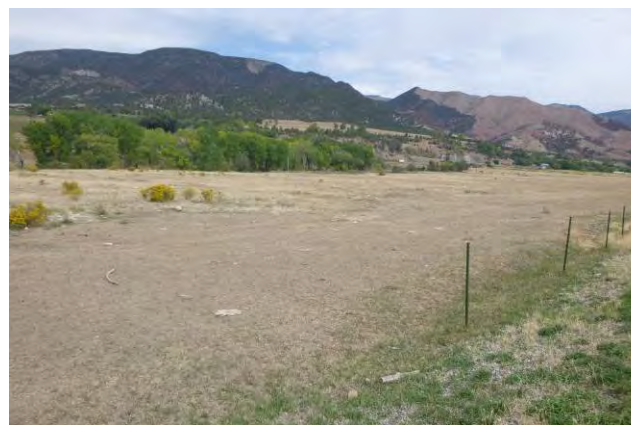
Typical conditions in the pasture areas.

Pastures. The pasture portions of the Property are dominated by agricultural cultivars including smooth brome (*Bromus inermis*), orchardgrass (*Dactylis glomerata*), western wheatgrass (*Pascopyrum smithii*), as well as some native fescues (*Festuca* spp.) and rabbitbrush (*Ericameria nauseosa*). The noxious weed cheatgrass (*Anisantha tectorum*) is common, and weedy adventitious species such as tumble mustard (*Sisymbrium* spp.) are also prevalent. In the spring, the introduced purple mustard (*Chorispora tenella*) and storkbill filaree (*Erodium cicutarium*) are also common. The site was grazed at the time of investigation, and additional pasture grasses are likely present and identifiable earlier in the grazing season. The condition of the pastures is typical of grazed or dryland pasture sites, with low levels of ground coverage and minimal diversity.

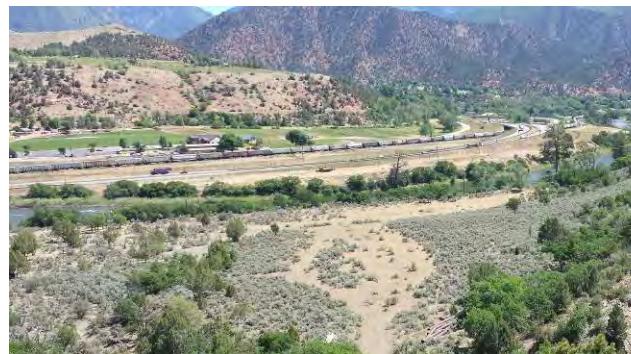
Typical conditions in ungrazed terrace areas, seen in center midground from the upgradient slope.

Some areas of the flat terrace on the Property are not grazed or irrigated and support a sparse coverage of sagebrush that is likely representative of original conditions.

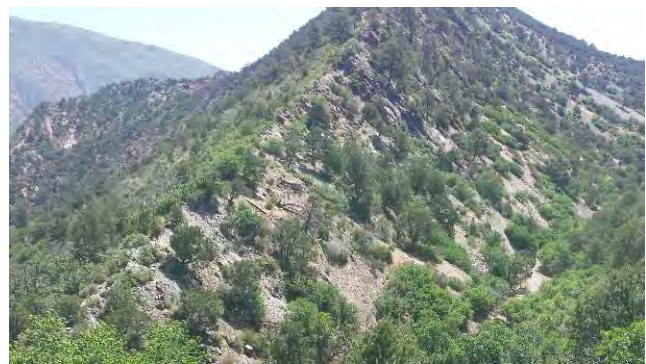
Typical mixed mountain shrublandsconditions on the Mancos slopes. Note sparse shrub coverage on the south-facing slope (center middle view), with greater abundance on the north-facing slopes (left middle view).

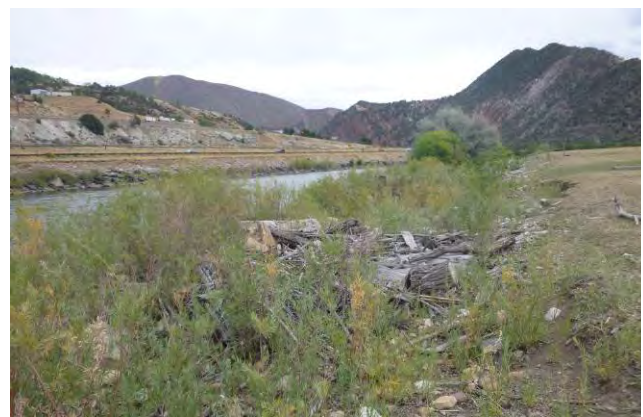
Willows dominate in small backwater reaches, adjacent to grazed pasture (right foreground).

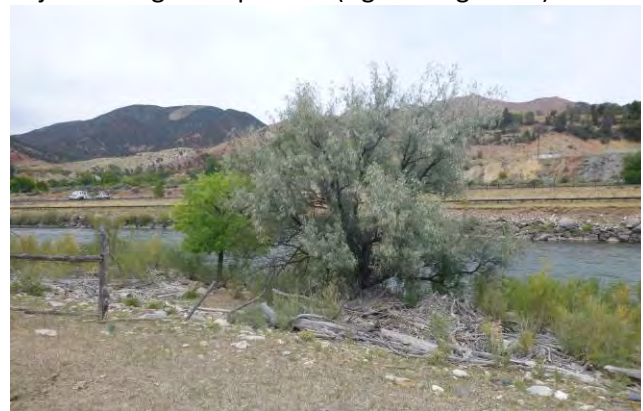
Isolated elm and Russian olive with minor willow Component.

Riparian/Wetlands. Within the channel of the Colorado River, isolated and discontinuous patches of riparian a vegetation occur on point bars and sheltered eddy banks. Vegetation is predominantly Chinese elm (*Ulmus parvifolia*), an invasive exotic tree species. Other notable species include narrowleaf cottonwood (*Populus angustifolia*), serviceberry, and dogwood (*Cornus stolonifera*). The banks are generally composed of large-diameter cobble material, which is well-drained and due to scouring, extensive wetlands do not occur. However, in protected eddy zones enough silt has collected to support small stands of coyote willow (*Salix exigua*) which suggest the presence of wetland conditions in these limited eddy zones. There are also small occurrences of the noxious weed species Russian olive (*Elaeagnus angustifolia*) and tamarisk (*Tamarix chinensis*). The riparian habitat is in poor condition, with minimal continuous canopy coverage over the river and a high percentage of exotics, likely due to historic grazing pressure.

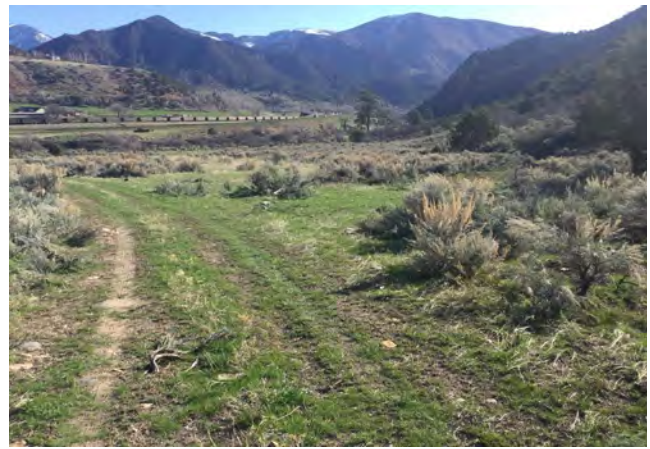
Typical conditions in remnant sagebrush shrublands.

Sagebrush Shrublands. Around the edges of the previously cleared and tilled pastures there are small remnant stands of sagebrush (*Artemisia tridentata* ssp. *bonwillensis*) shrublands. Along washes and in more well drained soils, great basin sagebrush (*A. t.* ssp. *tridentata*) can also be found. Understory vegetation is often compromised by cheatgrass, but desirable grasses and forbs include smooth brome, western wheatgrass, Indian ricegrass (*Acnatherum hymenoides*), and needle-and-thread grass (*Hesperostipa comata*).

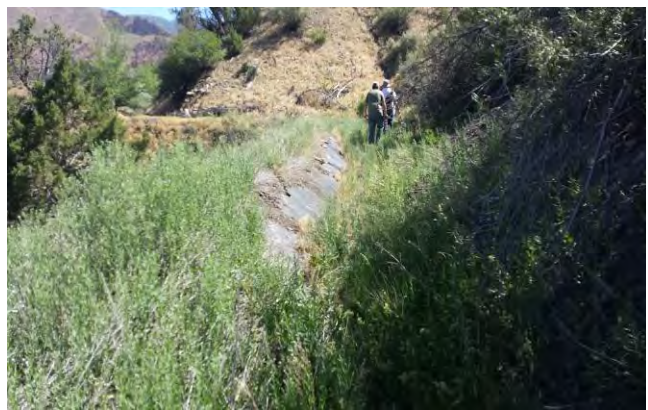
Typical ditch conditions dominated by weeds and excavated in an upland setting on Mancos shale slope

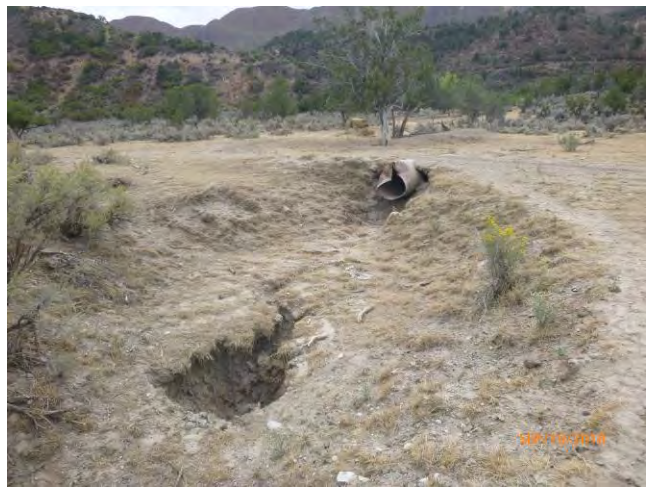
Unnamed intermittent drainage near terminus with Colorado River. Note lack of consistent flow indicators.

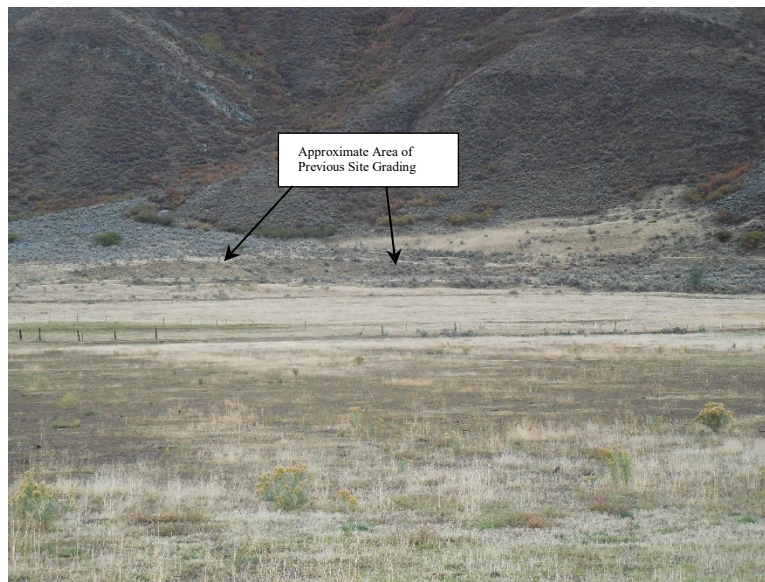
Photo 1 – Southwest portion of site looking south

Previous coal mining activity has occurred in areas south and west of the site. A coal mine is mapped about 1000 feet west of the site (See Figure 3). Our review of available mapping suggests that mining did not occur on or below this site. Mapping did suggest several locations where mine dumping occurred (See Figure 3). These materials consist of waste-rock debris from mining operations. In addition, observations made during our site visit indicated that previous grading activity has occurred in the southwest portion of the site. The approximate extents of this area are shown on Figure 3 and in Photo 1 below. Poorly compacted/low density

fill may be present in this area. Low density fill material could consolidate under structural loading from buildings or other improvements.
